# ARMY ENGINEER

magazine  
November–December 2011

# A T O W E R F O R H I L L 3 5

By Lt. Col. Doug Lehmann, USA (Ret)

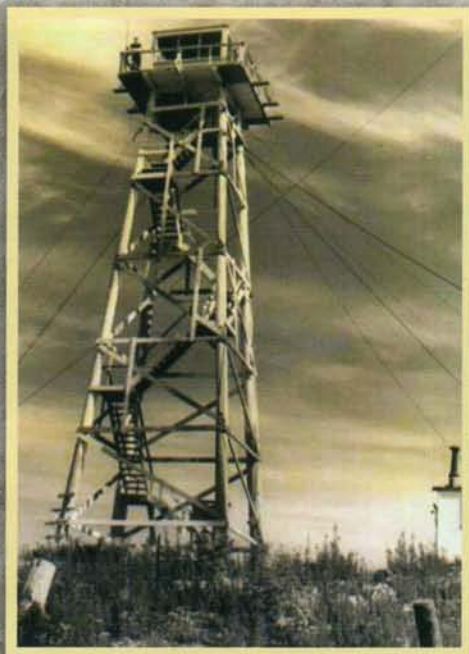
**FACING PAGE IMAGES CLOCKWISE: 1.** *This 1957 Forest Service fire lookout tower at Nooksack Fire Station near Deming, Washington is similar to the one at Hill 35. The Hill 35 version has a single exterior ladder replacing the interior stair cases and the top platform did not extend beyond the 4 corner poles and was unroofed. (Photo courtesy of the Skagit River Journal, see [www.skagitriverjournal.com](http://www.skagitriverjournal.com))* **2.** *Jeep mounted 23-Inch Xenon Searchlight, 100 amperes DC, 125 million candlepower, beam width 10 mils (pencil beam to 4 kilometers) to 120 mils (spread beam). (Photo from August 1967 Field Artillery Magazine, Vietnam Operations by CPT Gary E. Schultz, Page 53)* **3.** *30-Inch Xenon Searchlight, Battery I, 29th Field Artillery, at Fire Support Base Horseshoe, February 1970. The 196th LIB had a smaller 23-inch version. (Photo courtesy of the U.S.A. Center of Military History books, Vietnam Studies, Field Artillery, 1954-1973, by Major General David Ewing Ott.)* **4.** *Wire rope law "Never put a saddle on a dead horse."*
